Release Notes:

Version ST.1.0.090213 Software

for the HP ProCurve Threat Management Services zl Module

5900-0224
May 2009

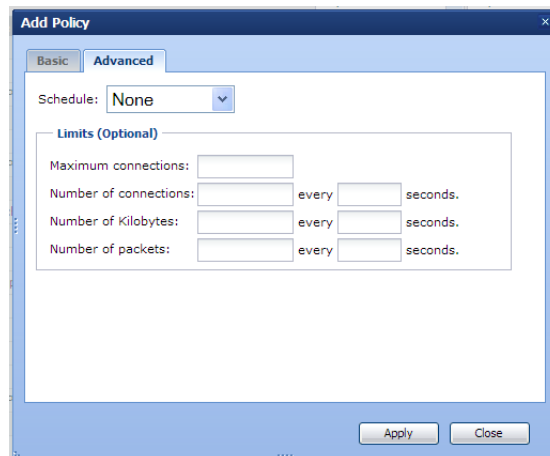
1. Use username/password to RADIUS Authenticate to the TMS z1 Module through the firewall.
 2. From a separate management session, delete all access for that user group
 3. The user still has access through firewall
- **PR_0000011874** — On the **Firewall > Access Policy > Unicast** page in the Web browser interface, when adding a policy there is an advanced tab that allows for limit settings.

The valid range for entries in **connections**, **Kilobytes**, **packets**, and **seconds** are not listed. The valid ranges are 1 - 4294967295 for all fields except **Kilobytes**, which is 1 - 4194304.
