# Release Notes:

## Version Q.11.17 Software

*for the ProCurve 2510-24 Switch*

5991-6274  
October 2008

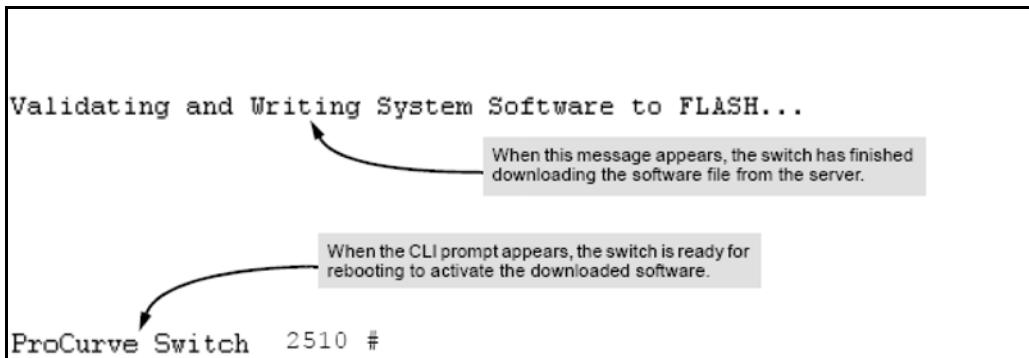
**Figure 1. Message Indicating the Switch Is Ready To Activate the Downloaded Software**

2. When the switch finishes downloading the software file from the server, it displays the progress message shown in figure 1. When the CLI prompt re-appears, the switch is ready to reboot to activate the downloaded software.
